WR[®]525 ELIMINATES FAILURES IN FEEDWATER PUMPS

Non-galling, Non-seizing Material Saves Company \$4–5 Million

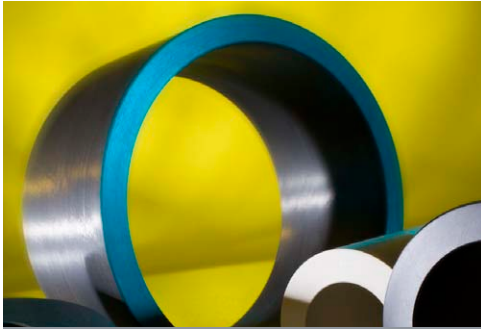
- Greene, Tweed recommended upgrading to WR[®]525, a non-galling, non-seizing thermoplastic composite

Based on the failure characteristics, Greene, Tweed recommended switching to a new bushing material – WR[®]525. A thermoplastic composite, WR525 consists of carbon fiber in a PEEK matrix. With non-galling, non-seizing properties, a low coefficient of thermal expansion, and exceptional thermal shock resistance, it could better withstand startup conditions than the 410SS used at the time.

In engineering new WR[®]525 breakdown bushings, Greene, Tweed was able to eliminate the original “toothed” design. Breakdown bushings reduce the differential pressure caused by variance in suction and discharge in a pump. In the original design, each labyrinth would act as a successive pressure barrier, with pressure dropping as media advanced from groove to groove. By upgrading to WR525, running clearances could be tighter due to the material’s non-galling, non-seizing properties. These tighter clearances achieved the same pressure reduction intended by the hardened steel, labyrinth design.
