# WR®600 Introduction

WR®600 is a carbon fiber-reinforced, Perfluoroalkoxy (PFA) based composite with a maximum continuous service temperature of 500°F (260°C).

**WR**<sup>®</sup>600 Components

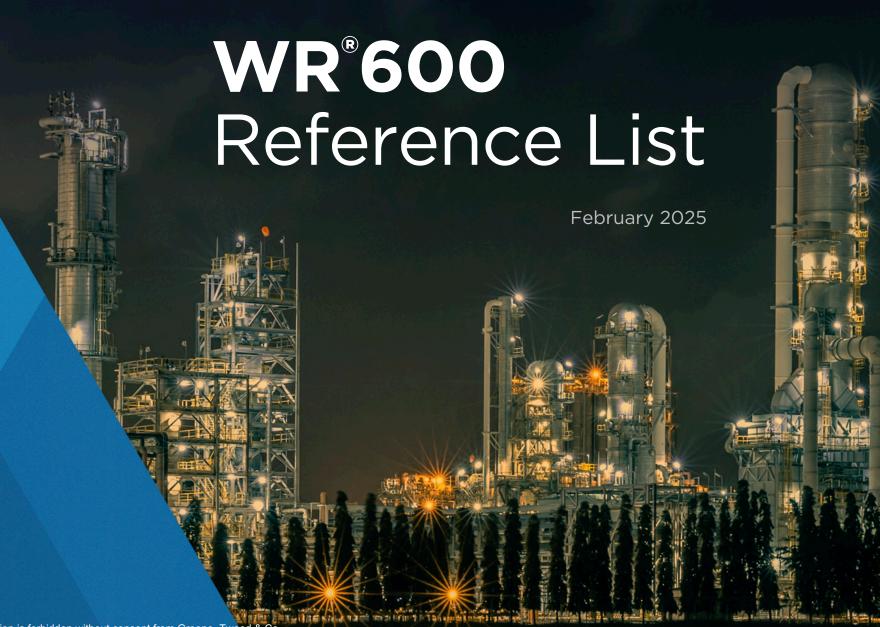
Its outstanding chemical resistance comes from its constituents. These material elements can withstand practically all environments, including the strongest acids, bases, halogens, and solvents.

In addition, WR®600 non-galling properties allow for extended periods of dry running during upset conditions.

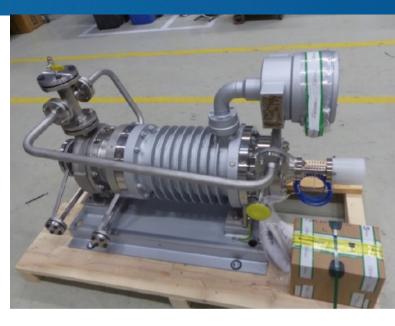
Part: Wear Rings for Hermetic Pump

**Previous Material:** Carbon Filled PEEK

**Problem Statement:** Excessive material swelling led to unreliable pump operation & frequent

unplanned maintenance. Mean Time Between Failure (MTBF) was weeks.

WR®600 Results: Extended MTBF from weeks to years of service

The Clariant site at Burgkichen has specified WR®600 for other Hermetic pumps in Ethylene Oxide service.

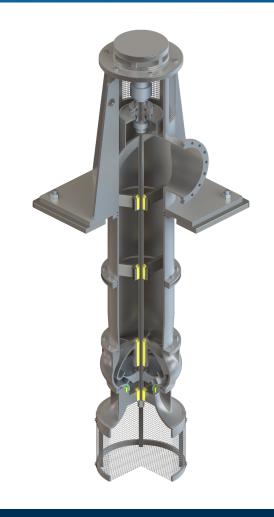
Part: Vertical pump sleeve bearing

Previous Material: Filled PEEK

**Problem Statement:** Chemical attack of the material resulted in bearing

swell & shaft seizure in minutes of operation

WR°600 Results: The chemical capability of WR°600 extended the life

of the bearing to 3 years.

WR®600 enabled reliable pump operation and is now being proliferated across the site.
