How Two Chemicals Companies Saved their Fertilizer Plant Carbamate Pumps from Catastrophic Failure

Greene Tweed's WR[®] 300 PEEK composite bushings and impeller wear rings improve reliability to save millions of dollars

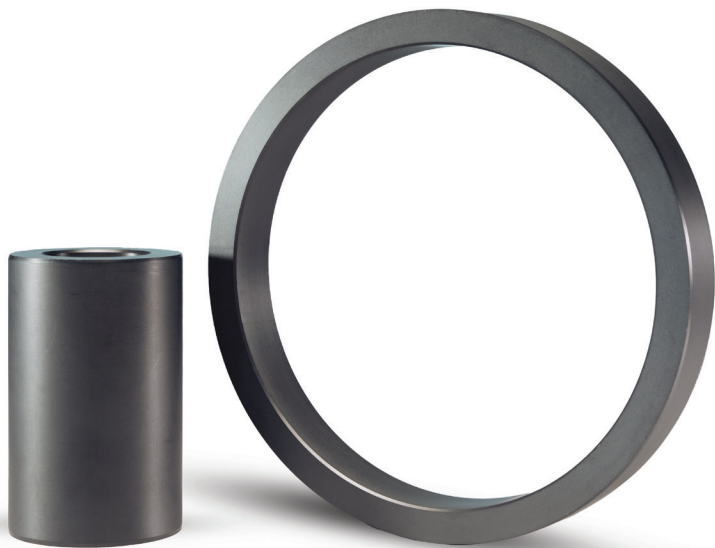
WR® 300 PEEK Composite

When the four centrifugal pumps at the plant were upgraded with bushings and impeller wear rings made of WR® 300 PEEK composite, they were able to restore the plants back to full production. Since then, no further pump failures have occurred. Encouraged, the end users placed additional spare orders in preparation to retrofit other pumps that were experiencing similar challenges. Based on this success, the OEM has standardized WR®300 in carbamate services.
